**Flood Control Project Maintenance  
Levee Inspections**  
**LMA District Cover Sheet**  
**Spring 2020 Levee Inspection Results**

**Sutter Maintenance Yard Maintenance Area 0017**

**Spring 2020 Levee Inspection Results**

Waterway			Bank	Unit Miles
Unit No. 01 Lake County Sutter Maintenance Yard - Middle Creek			Left	3.87
	Spring (March - May)	Summer (June - August)	(September - November) Fall	Winter (December - February)
Unit Maintenance Rating (Fall Only)				
Date of Inspection	3/4/2020 - 3/4/2020			
DWR Inspector	Luz Dial			
Accompanied By	Bryan Reniff DWR			
	Robert Duffey DWR

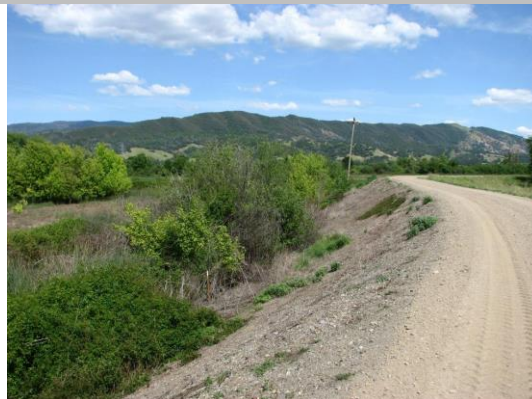
Photo 1 of 1 : SP\_2020\_MA0017\_339\_16\_20200302\_00003.jpg

LM Start	3.41	Rating **	M	Issue No.	30
LM End	3.50	Issue Type +	Ma	Location *	LS
Category	Earthen Levee			GPS Latitude/Longitude	
				Start	End
Item	Encroachments			39.148897 °	39.147927 °
				-122.912265 °	-122.911340 °
DWR ID	DWR_MA0017_01_s _ 2019_30				
Comment Code					
PR : Prunings					
Inspector Comment

5/2/2016: Remove or trim dense vegetation growing on fence to allow visibility and access to L/S toe.

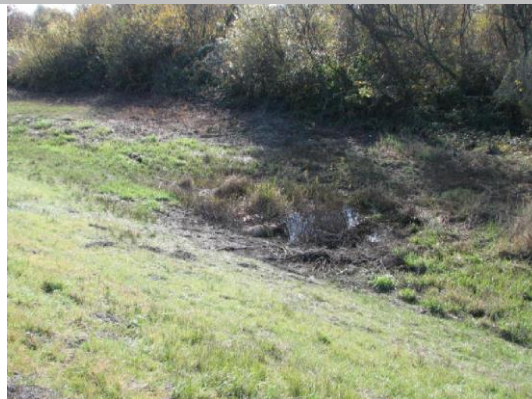
Photo 1 of 3 : UCIP\_SP\_2020\_55641\_46849.jpg

DS\_ID:844  
FS\_ID:55641  
EP\_NO: 11463  
Repair Type: Non-Urgent  
Crossing Status: Found  
UCIP Comments: 10/09/2019 The levee is maintained by DWR Sutter Yard. The State is currently working on purchasing adjacent land to eventually pursue the de-activation of this levee. Levee crown width through this section is about 12 feet. The UCIP inspection was completed with DWR Inspector, L. Dial, and DWR Sutter Yard Supervisor, B. Reniff. Crossing has been updated from No Action Needed to Non-Urgent; owner has changed [State owns structure]. (O. Magana - DWR UCIP)10/19/2016 Crossing appears to be in good condition. (DWR Sutter Yard- A/Freitag)06/14/2016 crossing appears to be in good condition.04/23/2015 No issues with pipe.07/03/2014 Same as last inspection.12/23/2013 Same as last inspection.08/02/2013 New flap gate installed. No other issues with pipe.  
FIELD\_STRUCT\_DESC: 24-inch corrugated metal drainage pipe through the levee, 12.4 feet below the crown. Flap gate on the waterside (WS) end. Timber walkway on the landside (LS) slope to a timber walkway to pump house mounted on piles in drainage ditch. (24-inch pipe [HLM 3.99] authorized under Automatic Board Order (ABO) issued as Permit No. 11463, 1975 - Audrey Jones). [Additional Reference(s): DWR Levee Log, 2005. USACE Sacramento O&M Manual 506.2, August 1961, (HLM 3.99)].

24-inch CMP at outlet on WS toe.

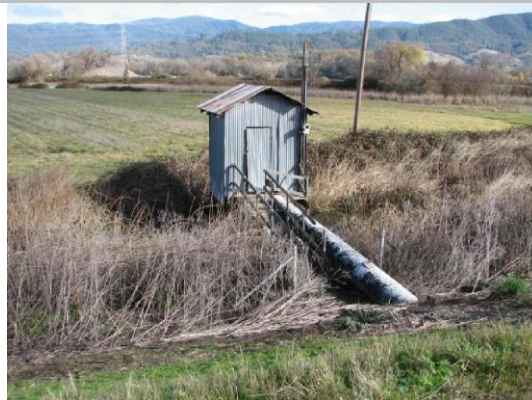
Photo 2 of 3 : UCIP\_SP\_2020\_55641\_46848.jpg

Pumphouse on piles at LS toe.

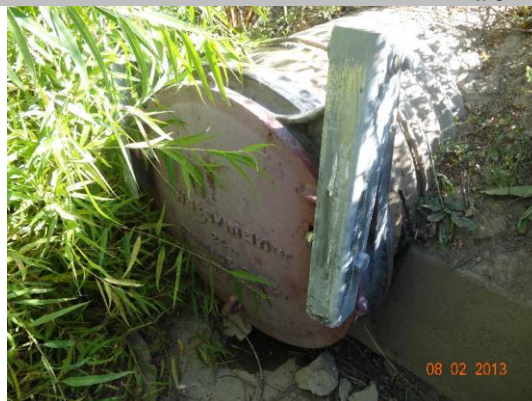
Photo 3 of 3 : UCIP\_SP\_2020\_55641\_46850.jpg

New flap gate on WS

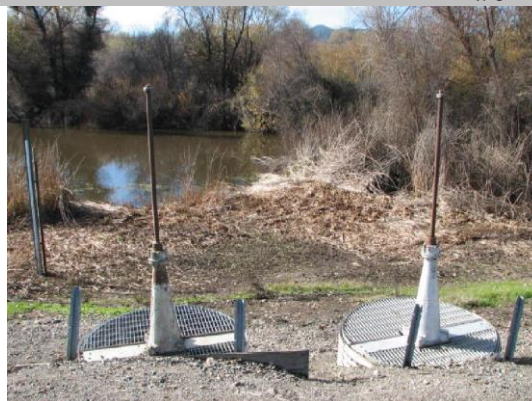
Photo 2 of 3 : UCIP\_SP\_2020\_55642\_46852.jpg

Slide gates in CMP risers on WS shoulder.

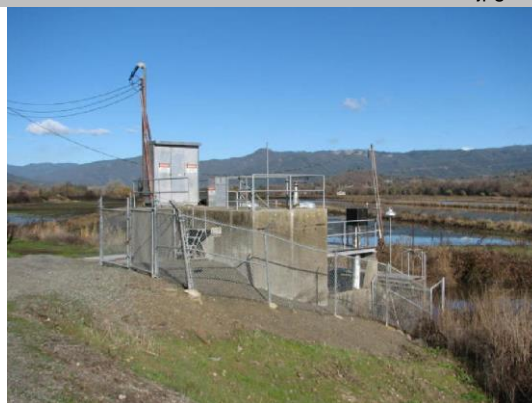
Photo 3 of 3 : UCIP\_SP\_2020\_55642\_46851.jpg

Pumping Plant on LS shoulder.

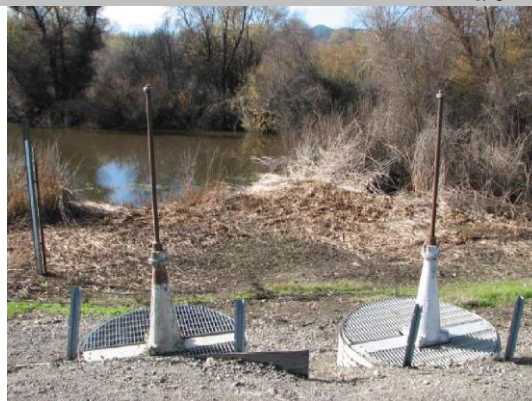
Photo 2 of 3 : UCIP\_SP\_2020\_56066\_46855.jpg

Slide gate in CMP riser on WS shoulder.

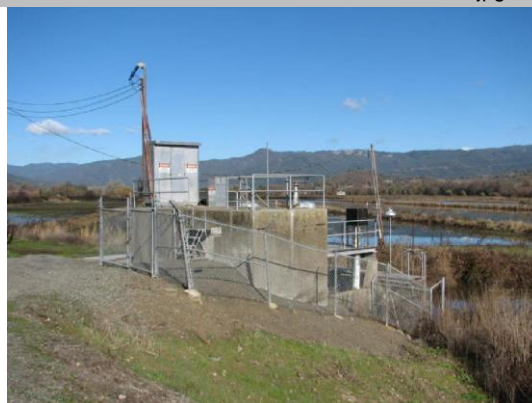
Photo 3 of 3 : UCIP\_SP\_2020\_56066\_46854.jpg

Pumping plant on LS shoulder.

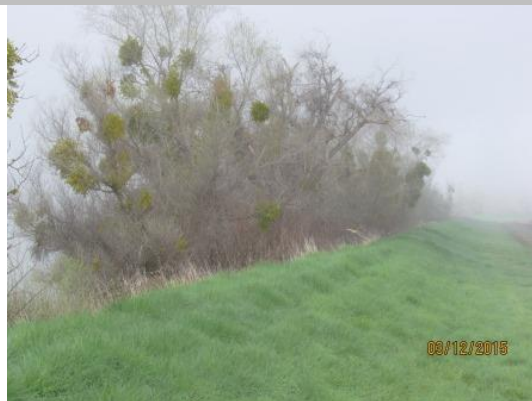
Photo 1 of 2 : SP\_2020\_MA0017\_339\_2\_20200302\_00001.jpg

LM Start	4.16	Rating **	U	Issue No.	2
LM End	7.10	Issue Type +	Ma	Location *	WS
Category	Earthen Levee			GPS Latitude/Longitude	
				Start	End
Item	Trim / Thin Trees			39.141894 °	39.120609 °
				-122.902201 °	-122.887166 °
DWR ID	DWR_MA0017_01_s_2012_2				
Comment Code					
T2 : Thin trees to allow visibility of the ground and room to flood fight.					
Inspector Comment					
Trees and limbs are completely obstructing visibility on crown and WS. The crown is too narrow to drive and overgrown with weeds, brush, and trees. The access road follows the LS toe.

View of the trees along the waterside slope and toe.

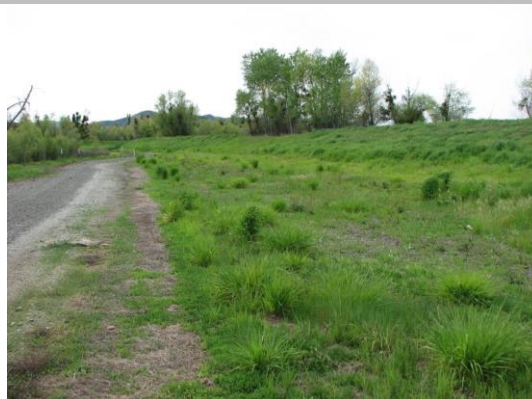
Photo 2 of 2 : SP\_2020\_MA0017\_339\_2\_20200302\_00002.jpg

Photo taken at LM 6.41 looking west showing overgrown LS slope of levee at right and toe road at left. Note trees obstructing visibility and access at levee crown. Crown is +/- 5 feet wide, and impassible to vehicles due to vegetation, and in some places, to pedestrians.  
4/19/2016

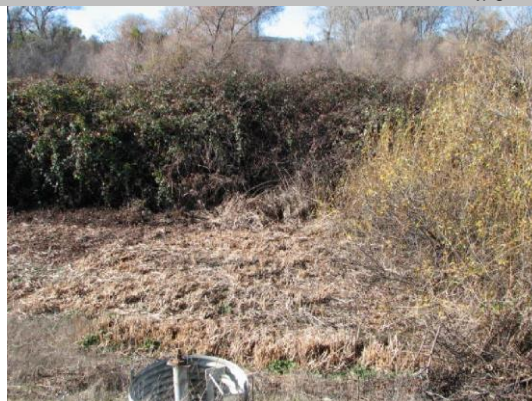
Photo 1 of 3 : UCIP\_SP\_2020\_56151\_46858.jpg

Comment Code						
Inspector Comment						
DS_ID:846 FS_ID:56151 EP_NO: 11462 Repair Type: Non-Urgent Crossing Status: Found UCIP Comments: 10/09/2019 The levee is maintained by DWR Sutter Yard. The State is currently working on purchasing adjacent land to eventually pursue the de-activation of this levee. Levee crown width ranges from 3 to 4-feet. The UCIP inspection was completed with DWR Inspector, L. Dial, and DWR Sutter Yard Supervisor, B. Reniff. Crossing remains Non-Urgent; unable to confirm owner or complete a thorough inspection due to limited access on the WS. Recommend auditing record to determine if ABO issued is still valid for this crossing. Recommend adding cover to CMP riser. (O. Magana - DWR UCIP)10/19/2016 No riser lid or slide gate wheel. (DWR Sutter Yard-AFreitag)06/14/2016 No riser lid and no wheel to operate screw gate.04/23/2015 Still no lid on riser and wheel to operate slide gate is missing.07/03/2014 Same as last inspection.12/23/2013 Same as last inspection.08/02/2013 Same as last inspection.12/13/2012 No lid on riser-may or may not be an issue. FIELD_STRUCT_DESC: 24-inch corrugated metal drainage pipe through the levee, 19 feet below the crown. Slide gate in 36-inch corrugated metal pipe (CMP) riser on the waterside (WS) slope. (24-inch drainpipe [HLM 4.31] authorized under Automatic Board Order (ABO) issued as Permit No. 11462, 1975 - Hobson) [Additional Reference(s): DWR Levee Log, 2005]. FS Date: 10/9/2019 3:01:00 PM

Slide gate in CMP riser on WS slope.

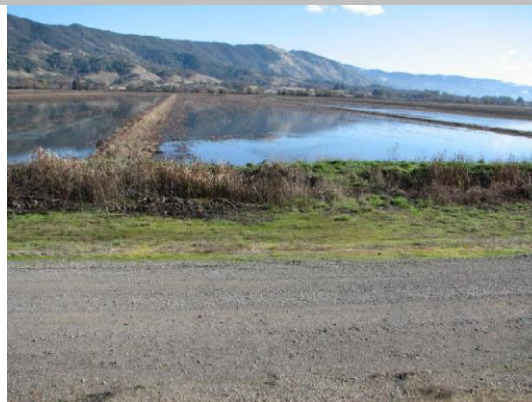
Photo 2 of 3 : UCIP\_SP\_2020\_56151\_46857.jpg

LS toe at approximate location of pipe inlet.

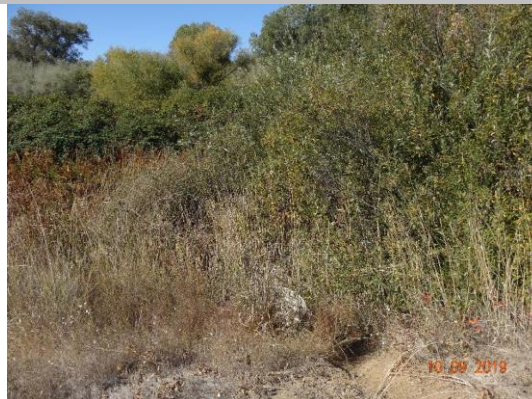
Photo 3 of 3 : UCIP\_SP\_2020\_56151\_82265.jpg

WS view: overview of WS. Dense vegetation limits inspection.

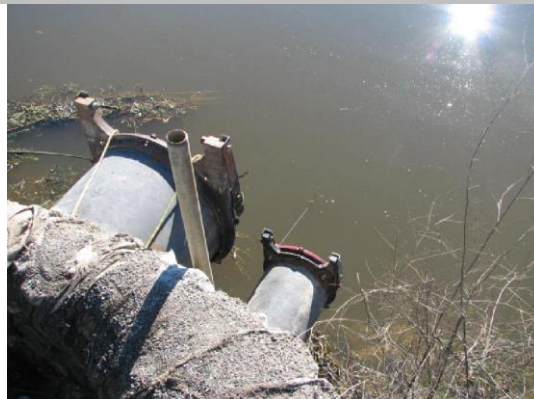
Photo 2 of 3 : UCIP\_SP\_2020\_55648\_46859.jpg

16-inch pipe, flap gate, air vent, and ring levee on WS slope.

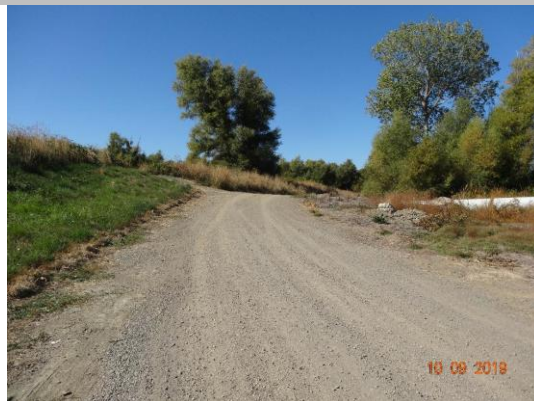
Photo 3 of 3 : UCIP\_SP\_2020\_55648\_82279.jpg

Overview of access road looking u/s towards pipe crossings.

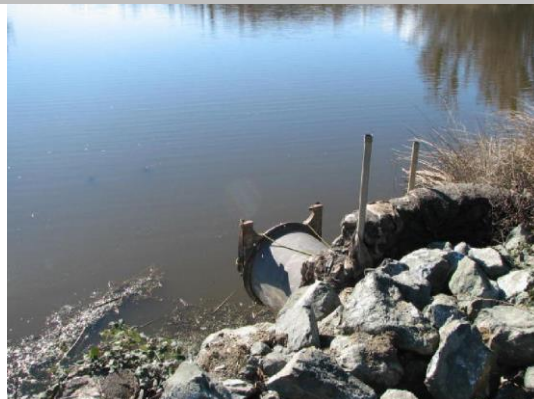
Photo 2 of 3 : UCIP\_SP\_2020\_55649\_46863.jpg

Pipe, flap gate, air vent, and sandbags on WS slope.

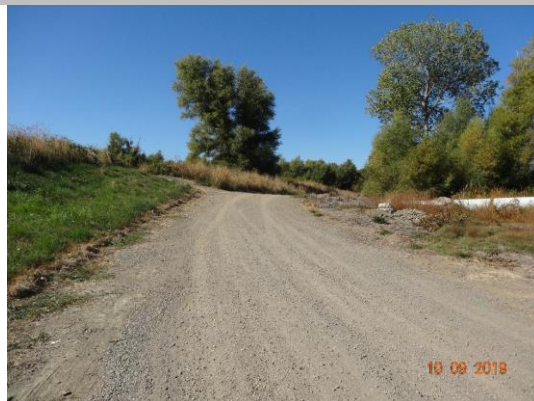
Photo 3 of 3 : UCIP\_SP\_2020\_55649\_82287.jpg

Overview of access road looking u/s towards pipe crossings.

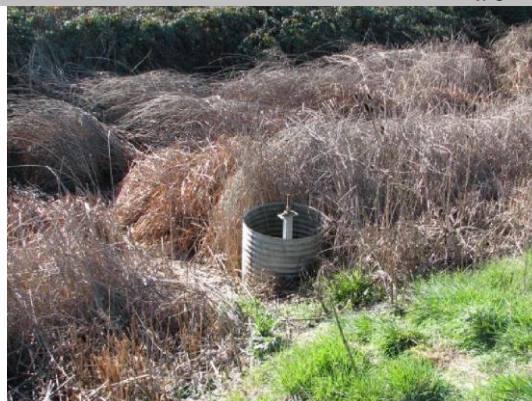
Photo 1 of 3 : UCIP\_SP\_2020\_55650\_46866.jpg

DS\_ID:848  
FS\_ID:55650  
EP\_NO: 11457  
Repair Type: Non-Urgent  
Crossing Status: Found  
UCIP Comments: 10/09/2019 The levee is maintained by DWR Sutter Yard. The State is currently working on purchasing adjacent land to eventually pursue the de-activation of this levee. Levee crown width ranges from 3 to 4-feet. The UCIP inspection was completed with DWR Inspector, L. Dial, and DWR Sutter Yard Supervisor, B. Reniff. Crossing remains Non-Urgent; crossing has been abandoned, no riser lid or slide gate wheel are present. DWR DMP geophysical investigation found signals of potential metal pipe through this section of the levee. Owner will need coordinate with the CVFPB to remove or abandon crossing according to Title 23 requirements. (O. Magana - DWR UCIP)

36-inch CMP riser and slide gate on WS slope.

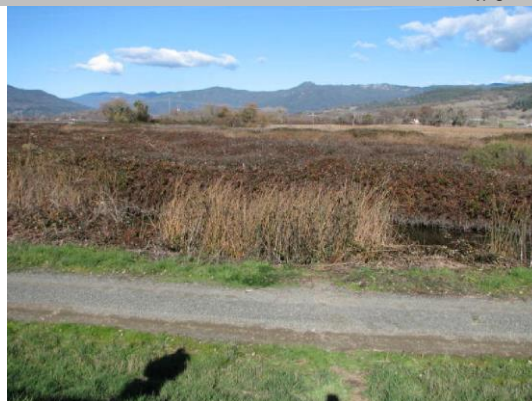
Photo 2 of 3 : UCIP\_SP\_2020\_55650\_46865.jpg

Approximate location of inlet on LS toe (not visible).

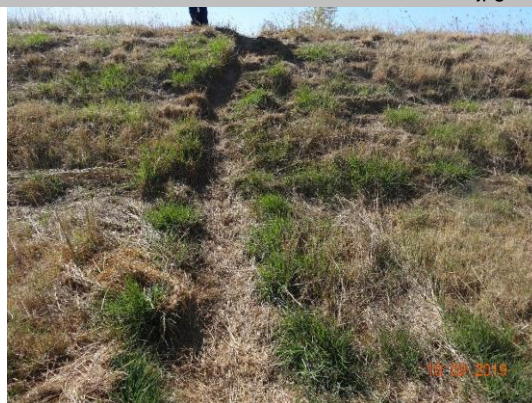
Photo 3 of 3 : UCIP\_SP\_2020\_55650\_82295.jpg

LS view: overview of LS slope.

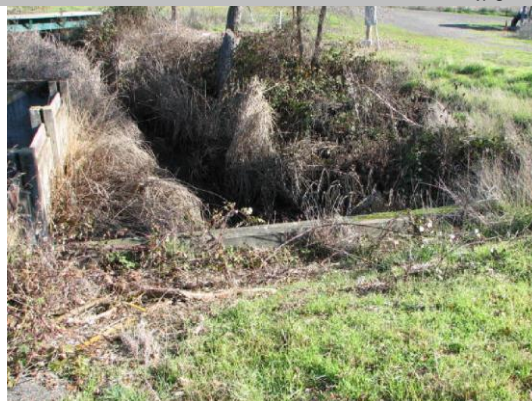
Photo 1 of 3 : UCIP\_SP\_2020\_55651\_46869.jpg

Comment Code						
Inspector Comment						
DS_ID:849 FS_ID:55651 EP_NO: 11467 Repair Type: Non-Urgent Crossing Status: Found UCIP Comments: 10/09/2019 The levee is maintained by DWR Sutter Yard. The State is currently working on purchasing adjacent land to eventually pursue the de-activation of this levee. Levee crown width is about 12 feet. The UCIP inspection was completed with DWR Inspector, L. Dial, and DWR Sutter Yard Supervisor, B. Reniff. Crossing has been updated from No Action Needed to Non-Urgent; need to audit record to confirm if ABO lists current owner for this structure. (O. Magana - DWR UCIP)10/27/2017 This structure is inspected annually under the Structure and Channel Summer Inspection (part of the Levee Inspection Program) conducted by the DWR Flood Project Integrity and Inspection Branch (FPIIB). (DWR UCIP - O. Magana) 10/19/2016 Crossing appears to be in good condition. (DWR Sutter Yard- A Freitag)06/14/2016 Flap gate propped open. Will make sure its closed before flood season.04/23/2015 Flap gate propped open. Not an issue at this time. Will close it before high water season.07/03/2014 Same as last inspection12/23/2013 Same as last inspection.08/02/2013 Same as last inspection. FIELD_STRUCT_DESC: [Highland Canal Diversion Weir and Drainage] 1 of 2: 54-inch corrugated metal drainage pipe through the levee 11.5 feet below the crown. Highland Canal Diversion Weir and Drainage Structure on the landside (LS). Concrete headwall on both landside (LS) and waterside (WS) toe with flap gate on the WS toe. (two 54-inch pipes [HLM 6.05] authorized under Automatic Board Order (ABO) issued as Permit No. 11467, 1975 - Modglin). [Additional Reference(s): DWR Levee Log, 2005, HLM 6.05. USACE Sacramento O&M Manual 506.3, August 1961, (HLM 6.05), two 54-inch pipes]. FS Date: 10/9/2019 3:05:00 PM

Concrete weir/dam and channel on LS toe.

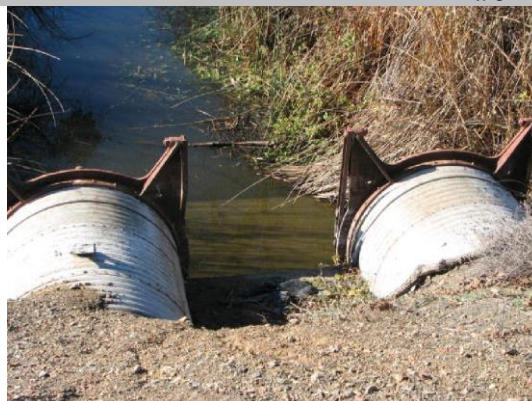
Photo 2 of 3 : UCIP\_SP\_2020\_55651\_46868.jpg

pipe and flap gate on WS toe.

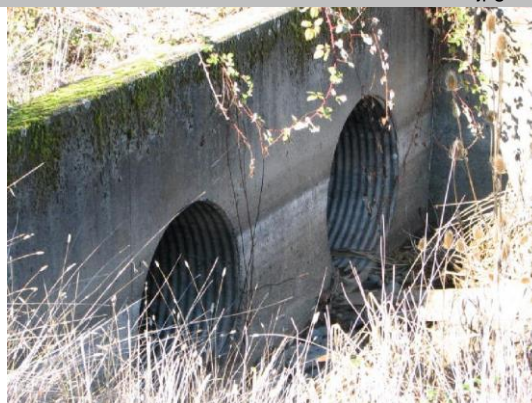
Photo 3 of 3 : UCIP\_SP\_2020\_55651\_46867.jpg

Concrete headwall at inlet on LS toe.

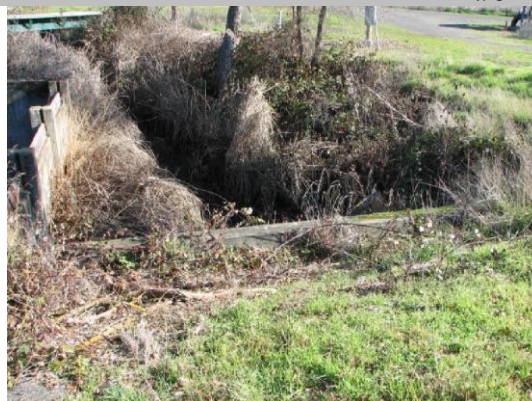
Photo 1 of 3 : UCIP\_SP\_2020\_55773\_46872.jpg

Comment Code						
Inspector Comment						
DS_ID:854 FS_ID:55773 EP_NO: 11467 Repair Type: Non-Urgent Crossing Status: Found UCIP Comments: 10/09/2019 The levee is maintained by DWR Sutter Yard. The State is currently working on purchasing adjacent land to eventually pursue the de-activation of this levee. Levee crown width is about 12 feet. The UCIP inspection was completed with DWR Inspector, L. Dial, and DWR Sutter Yard Supervisor, B. Reniff. Crossing has been updated from No Action Needed to Non-Urgent; need to audit record to confirm if ABO lists current owner for this structure. (O. Magana - DWR UCIP)10/27/2017 This structure is inspected annually under the Structure and Channel Summer Inspection (part of the Levee Inspection Program) conducted by the DWR Flood Project Integrity and Inspection Branch (FPIIB). (DWR UCIP - O. Magana) 10/19/2016 Crossing appears to be in good condition. (DWR Sutter Yard- A Freitag)06/14/2016 Flap gate propped open. Will make sure its closed before flood season.04/23/2015 Flap gate propped open. Not an issue at this time. Will close it before high water season.07/03/2014 Same as last inspection.12/23/2013 Same as last inspection.08/02/2013 Same as last inspection. FIELD_STRUCT_DESC: [Highland Canal Diversion Weir and Drainage] 2 of 2: 54-inch corrugated metal drainage pipe through the levee, 11.5 feet below the crown. Highland Canal Diversion Weir and Drainage Structure on the landside (LS). Concrete headwall on both landside (LS) and waterside (WS) toe with flap gate on the WS toe. (two 54-inch pipes [HLM 6.05] authorized under Automatic Board Order (ABO) issued as Permit No. 11467, 1975 - Modglin). [Additional Reference(s): DWR Levee Log, 2005, HLM 6.05. USACE Sacramento O&M Manual 506.3, August 1961, (HLM 6.05), two 54-inch pipes]. FS Date: 10/9/2019 3:06:00 PM

Concrete dam/weir and channel on LS toe.

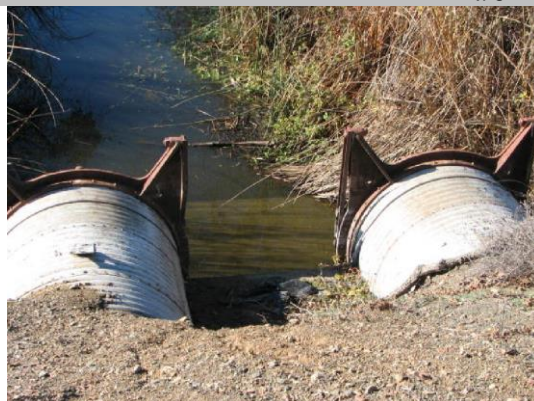
Photo 2 of 3 : UCIP\_SP\_2020\_55773\_46871.jpg

Pipe and flap gate on WS toe.

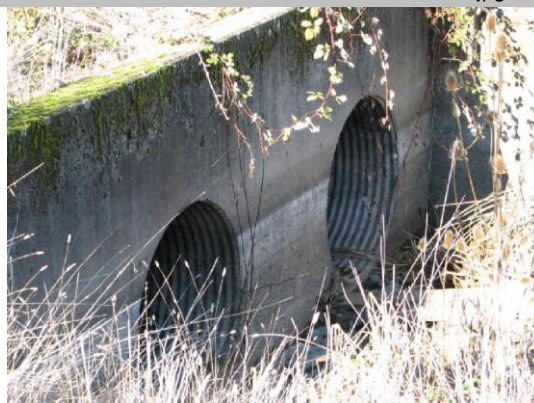
Photo 3 of 3 : UCIP\_SP\_2020\_55773\_46870.jpg

Concrete headwall on LS toe.

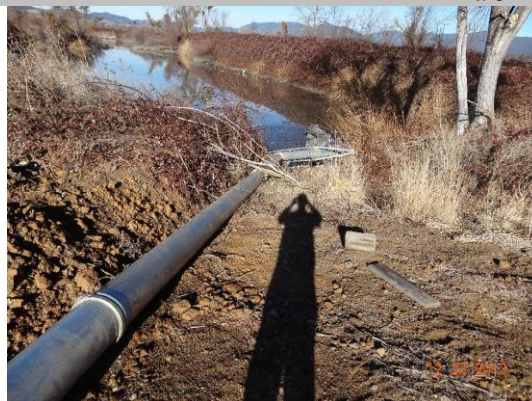
Photo 1 of 1 : UCIP\_SP\_2020\_55272\_47920.jpg

Comment Code					
Inspector Comment					
DS_ID:20589 FS_ID:55272 EP_NO: N/A Repair Type: Non-Urgent Crossing Status: Found UCIP Comments: 10/09/2019 Record remains Non-Urgent, unable to determine the status of this pipe through the levee. (O. Magana - DWR UCIP)10/19/2016 12" pipe not present for this inspection. (DWR Sutter Yard- A Freitag)06/14/2106 12" pipe was removed from the roadway. Portable pump was not found on the bank this time.04/23/2015 12" pipe still ran over the top of roadway.  07/03/2014 Same as last inspection.12/23/2013 No signs of 12" pvc. Portable tow-pump was lowered down on waterside with 12" pipe ran over roadway.08/02/2013 Same as last inspection.12/13/2012 No permit for crossing. FIELD_STRUCT_DESC: *REMOVED* 12-inch high-density polyethylene (HDPE) drainage pipe through the levee, 1.5 feet below the crown. No permit has been identified since crossing was field discovered in 2012. FS Date: 10/9/2019 3:09:20 PM

Portable pump on WS and temporary piping over roadway

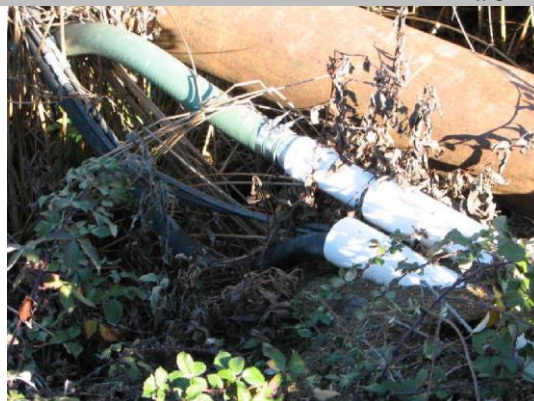
Comment Code						
Inspector Comment						
DS_ID:20587 FS_ID:55653 EP_NO: N/A Repair Type: Urgent Crossing Status: Found UCIP Comments: 10/09/2019 The levee is maintained by DWR Sutter Yard. The State is currently working on purchasing adjacent land to eventually pursue the de-activation of this levee. Levee crown width is more than 12 feet. The UCIP inspection was completed with DWR Inspector, L. Dial, and DWR Sutter Yard Supervisor, B. Reniff. Crossing remains Urgent; WS erosion is still present along WS slope. This crossing is also considered an unauthorized encroachment. It appears that this pipe is conveying water from WS to LS and LS to WS. No owner has been identified for this crossing. (O. Magana - DWR UCIP)09/06/2018 Same as last inspection; WS erosion is still present so the crossing remains Urgent (D. Sanoski - DWR UCIP).10/19/2016 WS erosion still present. (DWR Sutter Yard-afreitag)06/14/2016 WS erosion is still present. (DWR Sutter Yard - afreitag)04/23/2015 Erosion on WS shoulder is still present. (DWR Sutter Yard - afreitag)07/03/2014 Same as last inspection. (DWR Sutter Yard - afreitag)12/23/2013 Same as last inspection. (DWR Sutter Yard - afreitag)08/02/2013 Erosion on WS shoulder above pipes. (DWR Sutter Yard - afreitag)12/13/2012 No permit for this crossing. This is a primer line, used to fill up main pipe before its pump is turned on (Permit No. 11467). (DWR UCIP - wwylie) FIELD_STRUCT_DESC: 4-inch polyvinyl chloride (PVC) conduit of an unknown purpose through the levee, 2 feet below the crown, with plastic pipe running through it to pump on the landside (LS). No permit has been identified since crossing was field discovered in 2012. FS Date: 10/9/2019 2:55:00 PM

4-inch pvc pipe with green flexible pipe running through it on WS shoulder.

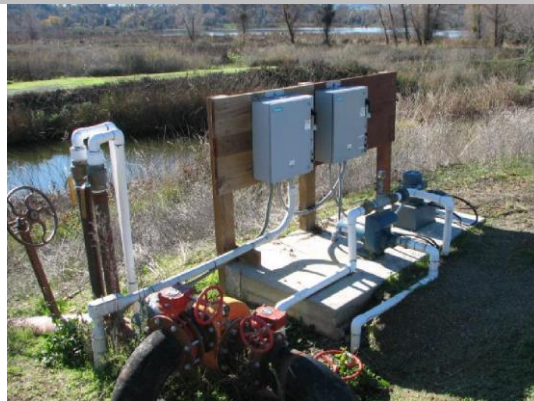
Photo 3 of 3 : UCIP\_SP\_2020\_55653\_46876.jpg

LS pump station on shoulder.

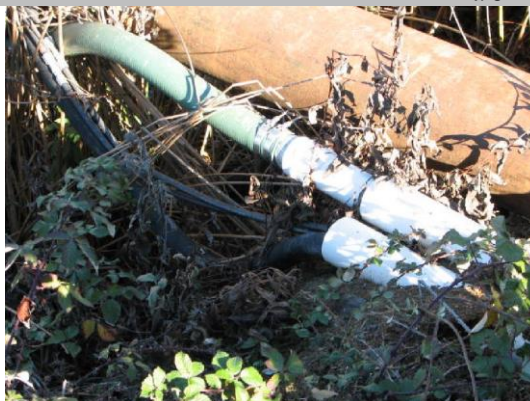
Photo 1 of 3 : UCIP\_SP\_2020\_55656\_46874.jpg

DS\_ID:20588  
FS\_ID:55656  
EP\_NO: N/A  
Repair Type: Urgent  
Crossing Status: Found  
UCIP Comments: 10/09/2019 The levee is maintained by DWR Sutter Yard. The State is currently working on purchasing adjacent land to eventually pursue the de-activation of this levee. Levee crown width is more than 12 feet. The UCIP inspection was completed with DWR Inspector, L. Dial, and DWR Sutter Yard Supervisor, B. Reniff. Crossing remains Urgent; WS erosion is still present along WS slope. This crossing is also considered an unauthorized encroachment. It appears that this pipe is conveying water from WS to LS and LS to WS. No owner has been identified for this crossing. (O. Magana - DWR UCIP)09/06/2018 Same as last inspection; WS erosion is still present so the crossing remains Urgent (D. Sanoski - DWR UCIP).10/19/2016 WS erosion still present. (DWR Sutter Yard- AFreitag)06/14/2016 WS erosion is still present. (DWR Sutter Yard - afreitag)04/23/2015 Erosion still present on WS shoulder. (DWR Sutter Yard - afreitag)07/03/2014 Same as last inspection. (DWR Sutter Yard - afreitag)12/23/2013 Same as last inspection. (DWR Sutter Yard - afreitag)08/02/2013 Erosion on WS shoulder above pipes. (DWR Sutter Yard - afreitag)12/13/2012 No permit for this crossing. It is unclear what these hydraulic lines are for, but it is probably the works for a hydraulic butterfly valve at the outlet. (DWR UCIP - wwylie)

Pipe and hydraulic lines on WS shoulder.

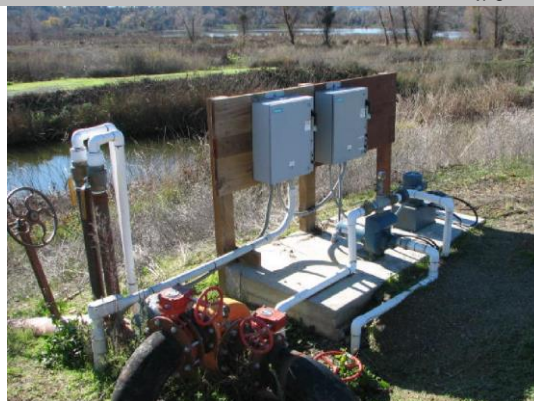
Photo 2 of 3 : UCIP\_SP\_2020\_55656\_46873.jpg

Pump station on LS shoulder, see hydraulic pump at right.

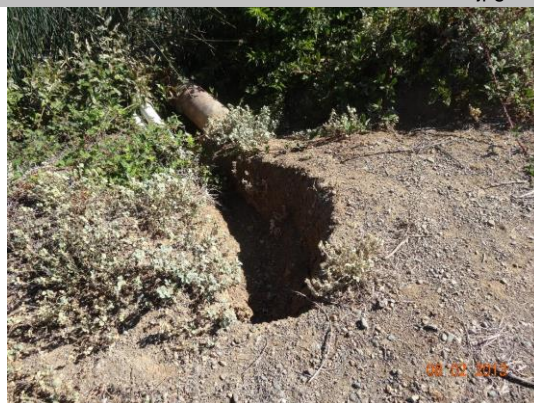
Photo 3 of 3 : UCIP\_SP\_2020\_55656\_46875.jpg

Erosion on WS shoulder

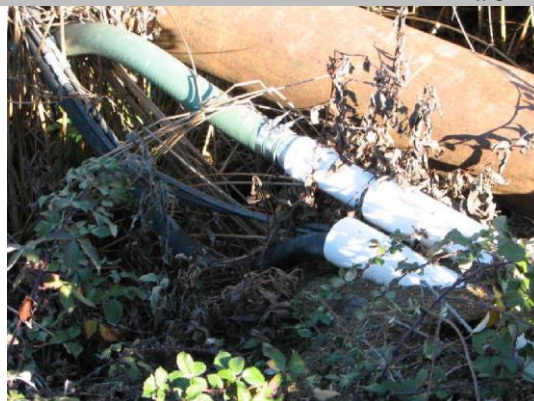
DS\_ID:850  
FS\_ID:56065  
EP\_NO: 11467  
Repair Type: Urgent  
Crossing Status: Found  
UCIP Comments: 10/09/2019 The levee is maintained by DWR Sutter Yard. The State is currently working on purchasing adjacent land to eventually pursue the de-activation of this levee. Levee crown width is more than 12 feet. The UCIP inspection was completed with DWR Inspector, L. Dial, and DWR Sutter Yard Supervisor, B. Reniff. Crossing remains Urgent; WS erosion is still present along WS slope. This crossing has been modified. It appears that this pipe is conveying water from WS to LS and LS to WS. Recommend auditing record to determine current owner. (O. Magana - DWR UCIP)09/06/2018 Same as last inspection; WS erosion is still present so the crossing remains Urgent (D. Sanoski - DWR UCIP).10/19/2016 WS erosion still present. (DWR Sutter Yard- A Freitag)06/14/2016 WS erosion is still present. (DWR Sutter Yard - a Freitag)04/23/2015 Same as last inspection. (DWR Sutter Yard - a Freitag)07/03/2014 Same as last inspection. (DWR Sutter Yard - a Freitag)12/23/2013 Same as last inspection. (DWR Sutter Yard - a Freitag)08/02/2013 Same as last inspection. (DWR Sutter Yard - a Freitag)12/13/2012 The pipe and appurtenances do not match what was described in the permit (PN: 11467). Does not appear to be in compliance with board regulations. (DWR UCIP - wylie)

12-inch pipe and appurtenances on WS shoulder.

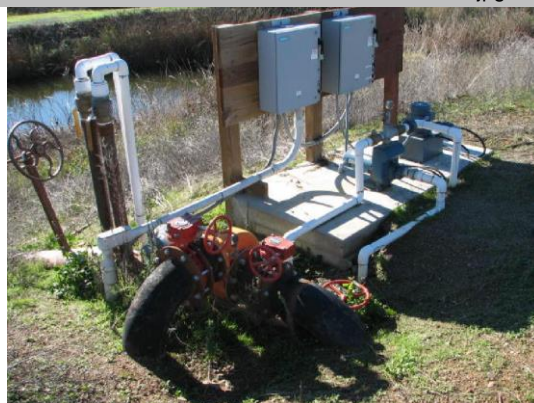
Photo 3 of 3 : UCIP\_SP\_2020\_56065\_46880.jpg

Pumping plant and appurtenances on LS shoulder.

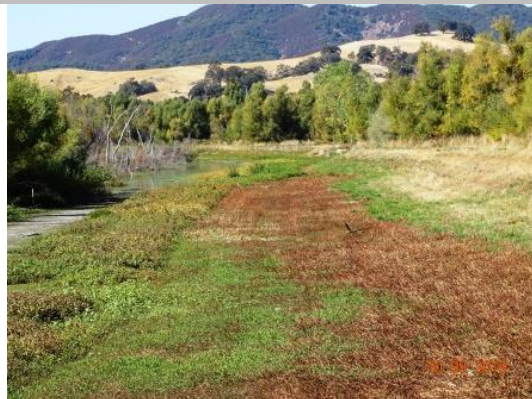
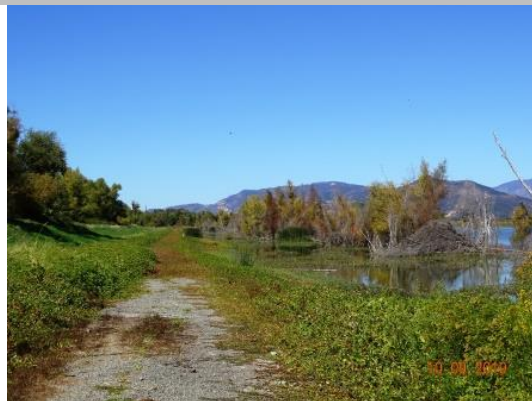
View of water past the levee toe. Fall 2019

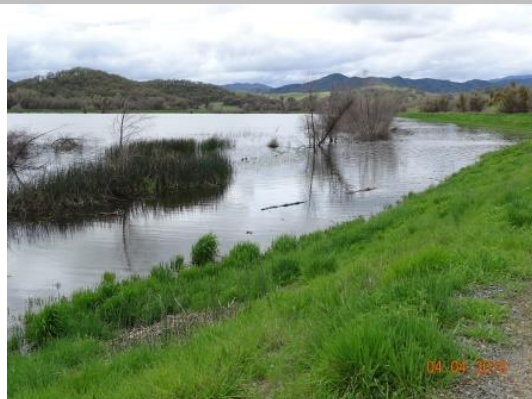
Photo 3 of 3 : SP\_2020\_MA0017\_339\_23\_20200302\_00006.jpg

View of water at the levee toe. Spring 2019

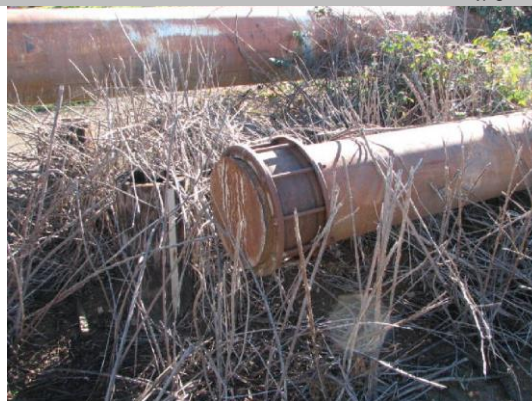
Photo 2 of 3 : UCIP\_SP\_2020\_55658\_46883.jpg

Steel plate welded over end of pipe at LS toe.

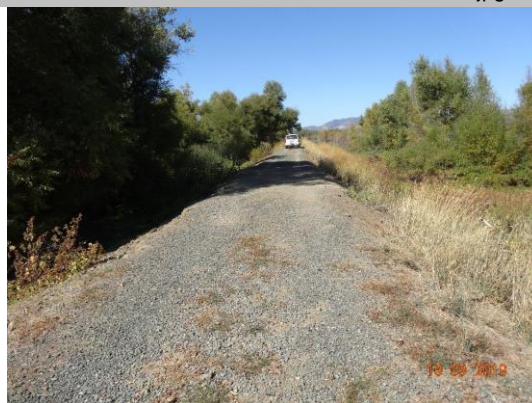
Photo 3 of 3 : UCIP\_SP\_2020\_55658\_82325.jpg

Overview of levee crown looking u/s towards pipe crossing.

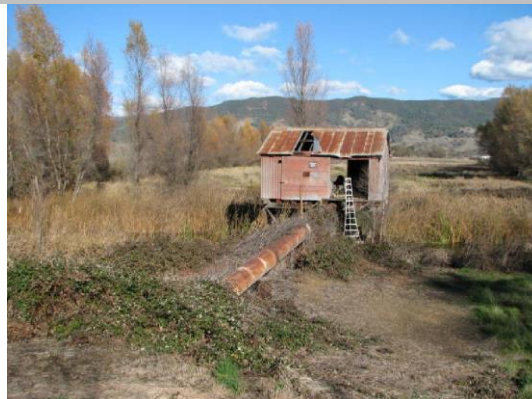
Photo 1 of 3 : UCIP\_SP\_2020\_55660\_46886.jpg

24-inch steel pipe and pump house on LS.

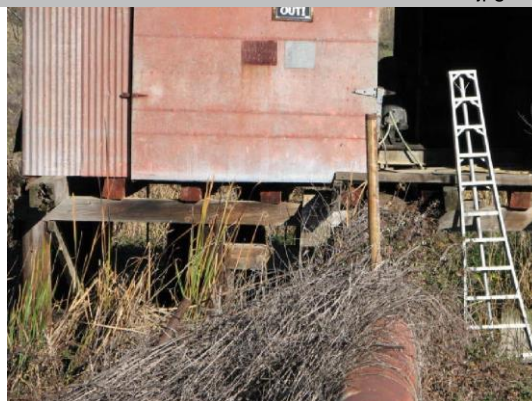
Photo 2 of 3 : UCIP\_SP\_2020\_55660\_46885.jpg

Air vent on pipe at LS pumphouse.

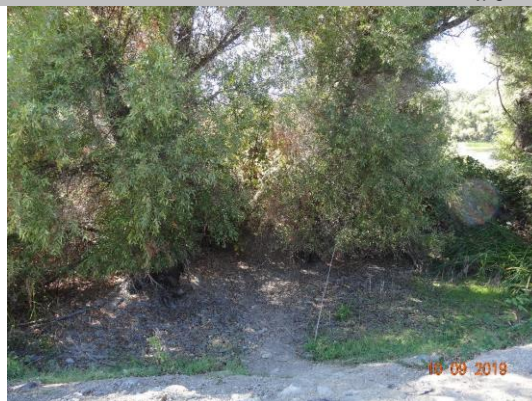
Photo 3 of 3 : UCIP\_SP\_2020\_55660\_82331.jpg

WS view: overview of WS.
